AMY BAUR^{1*}, JOHN CHRISTY², PATRICK HENDRIX¹, GLEN LEVERICH¹, ELAINE STEWART³, JOHN CATENA³, AND JEREMY KIRBY³

¹STILLWATER SCIENCES, PORTLAND, OR, ²PORTLAND STATE UNIVERSITY, PORTLAND, OR, ³METRO, PORTLAND, OR

INTRODUCTION

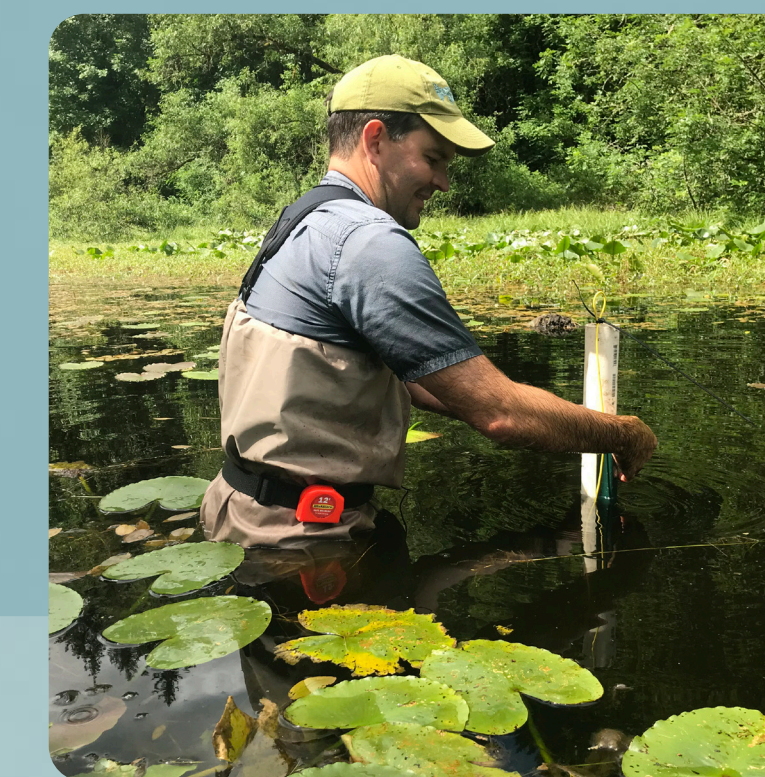
The quantity and pathways of hydrologic inputs—rainfall, surface runoff, and groundwater discharge—can alter the fen's health and overall existence. Surface-drainage pathways were mapped in detail following a desktop GIS-based exercise ground-truthed by a comprehensive field survey. Water levels and temperatures in the lake, a nearby seasonal pond, and nearby groundwater monitoring points were gaged continuously to further evaluate seasonal inflow and outflow pathways.

- The study site qualifies physically as a “basin fen”, meaning it is fed by both surface-water and groundwater
- The system receives hydrologic input from rainfall, local runoff, and groundwater
- Lake and nearby pond levels fluctuate seasonally
- The longitudinal profile of the fen lake and surroundings (shown above) reveals a unique hydrogeologic profile having counter flow direction
- Surface runoff typically trends to the north (right side of graphic above) while groundwater flow consistently trends to the south (left side of graphic above) parallel to the bedrock inclination

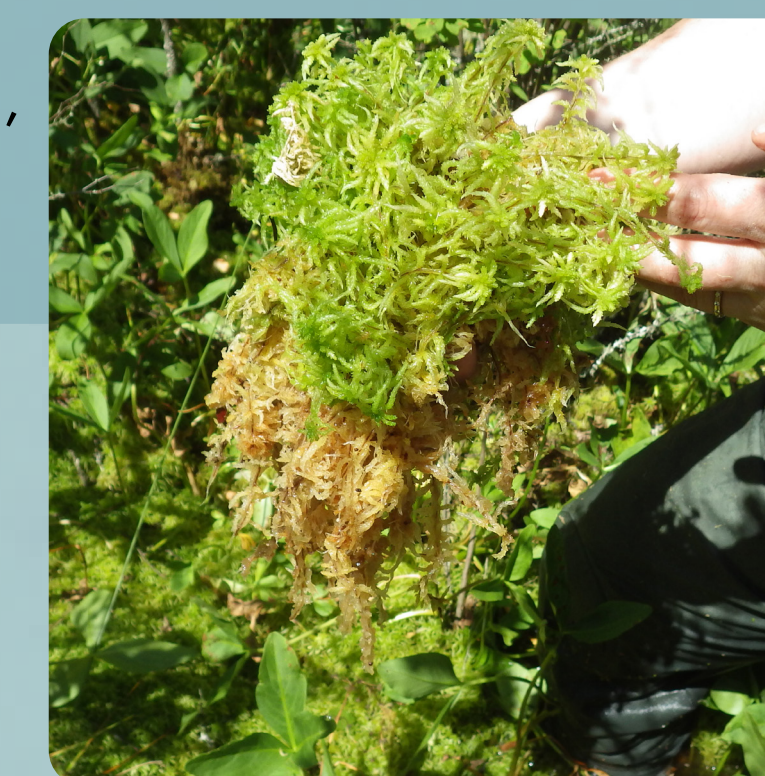
Soil conditions are intrinsically linked to fen health, being both a sink and source of dissolved elements. Assessment of soils included soil textures, bedrock depth, organic content (peat presence and texture), and chemical properties (pH, nutrients, and major cations).

- Soil in the lake bottom is acidic (pH: 4.9)
- Organic content is very high
- Peat layer is more than 30 inches thick
- Shoreline soils are sandy silts, typical of Willamette Valley floodplains, and contain less organic matter

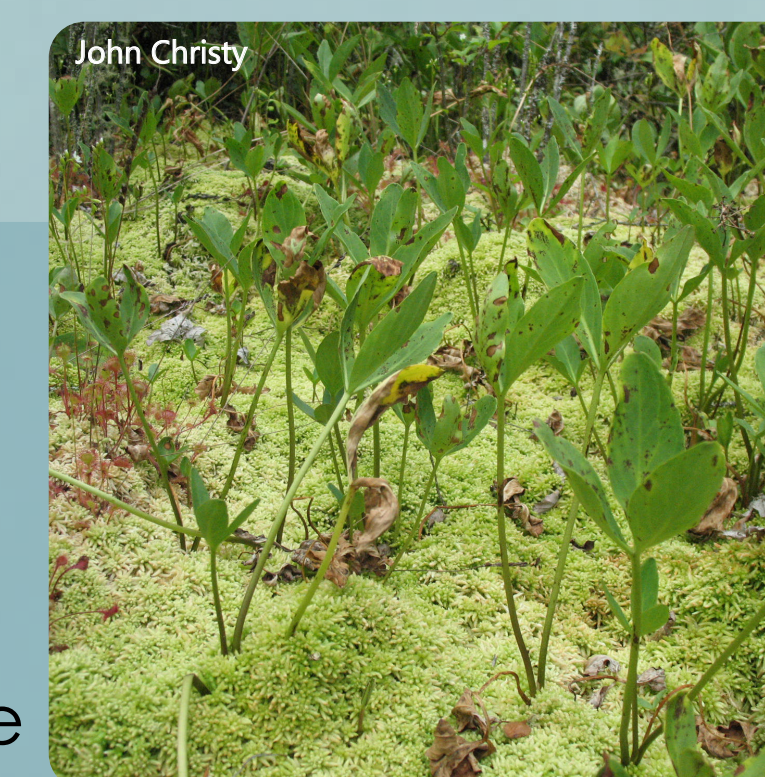
Tracking the spatial extent of the fen system, particularly the lake and its floating mat, are important in detecting fen degradation and ensuring its preservation. An Unmanned Aircraft System (UAS) coupled with targeted field reconnaissance was used to create a detailed baseline map of the fen system and the thickness of the floating mat was measured manually in the field.

- Thickness of the floating mat was inconclusive but indicated that the center of the floating mat is at least 6 feet thick, with multiple thin spots present throughout
- When compared to previous studies, the thickness of the floating mat and seasonal recharge of lake levels indicate that the water supply to the fen appears to be relatively stable and the configuration and extent of the mat and open water has not changed appreciably in 85 years
